Manhole Inspection Summary

Manhole # S23A1_006MH

Insp Date: **7/9/08 10:45 AM**

Location Address: **2304 Severn St.**

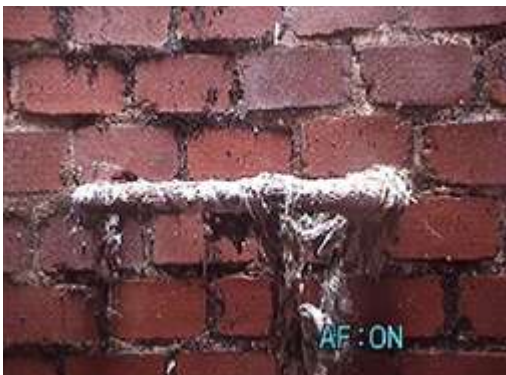
Defect 3

☒ Evidence Of Surcharge Depth: **6** (ft.) ☐ Active Surcharge Present

Evidence of surcharge

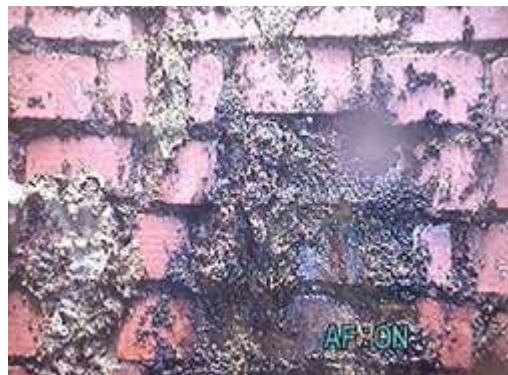
Defect 2

Infiltration: ☐ None ☐ Joint ☐ Cracks ☒ Mortar ☐ Roots ☐ Wall

Infiltration at corbel mortar (mud deposits)

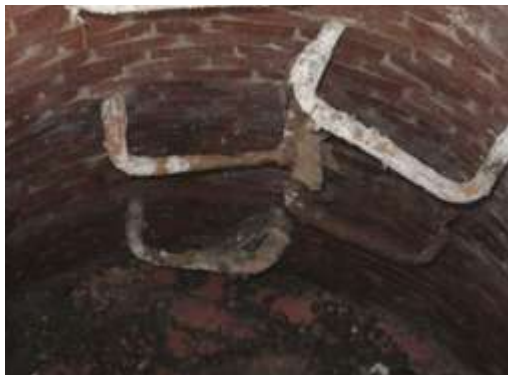
Defect 1

Count: **5** Missing: **0** ☒ Corroded

Corroded steps

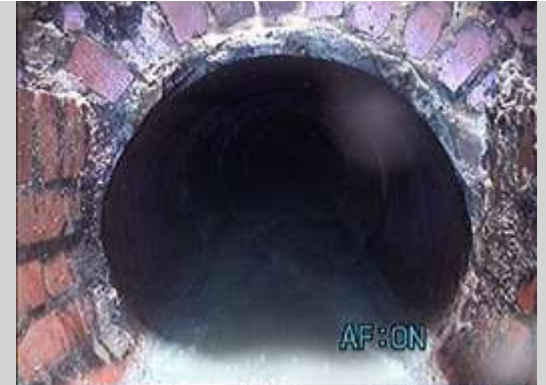
12 O'Clock Outflow

21 in. Circular Gravity Sewer
Pipe Out @ 12 O'Clock

Pipe Height: **21.6** (in.) Rod and Bar (Angled)
Pipe Material: **Clay** ☐ Pipe Lined
Invert Depth: **11.00** (ft.) Flow Characteristics: **Fast**
Deposits: ☒ None ☐ Mud ☐ Sludge ☐ Debris ☐ Grease
Silt Depth: **0** (in.) Deposits Extent:
Infiltration: **None** Pipe Seal Cond: **Sound**

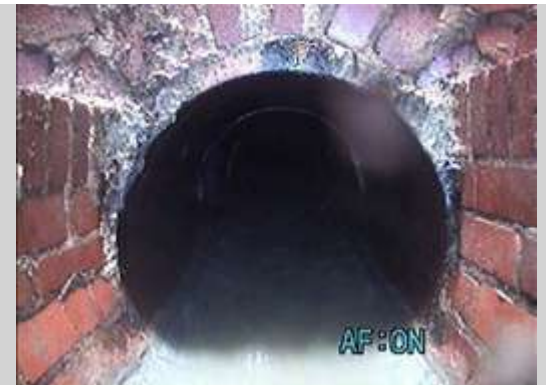
6 O'Clock Inflow

18 in. Circular Gravity Sewer
Pipe In @ 6 O'Clock

Pipe Height: **18** (in.) Rod and Bar (Angled)
Pipe Material: **Clay** ☐ Pipe Lined
Invert Depth: **10.65** (ft.) Flow Characteristics: **Fast**
Deposits: ☒ None ☐ Mud ☐ Sludge ☐ Debris ☐ Grease
Silt Depth: **0** (in.) Deposits Extent:
Infiltration: **None** Pipe Seal Cond: **Sound**

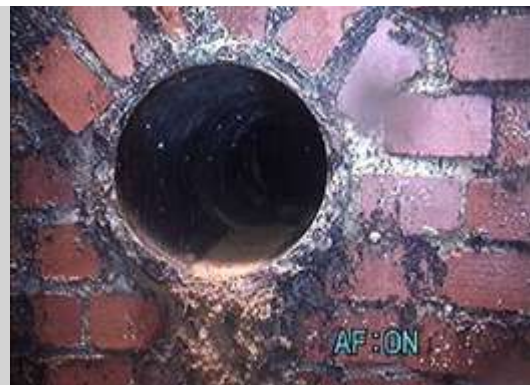
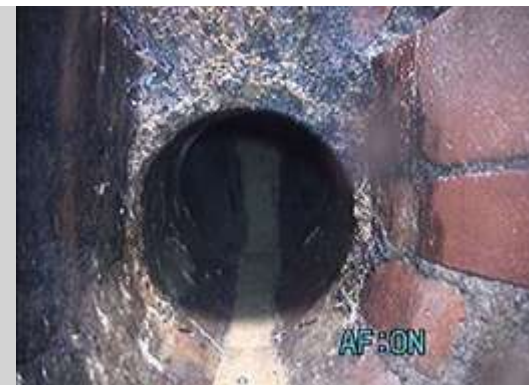
9 O'Clock Inflow

8 in. Circular Gravity Sewer

Pipe Height: **8.4** (in.) Rod and Bar (Angled)

Infiltration: **None** Pipe Seal Cond: **Sound**

Drop: **Outside** Rod and Bar

Drop Condition: **Open**
